Subject: 2011 Trophic Status Index Mapping Flight Report

On August 3<sup>rd</sup>, 2011 AWRL conducted a TSI Mapping Flight of Upper South Long Lake (MN ID#18-0096) in Crow Wing County, Minnesota.

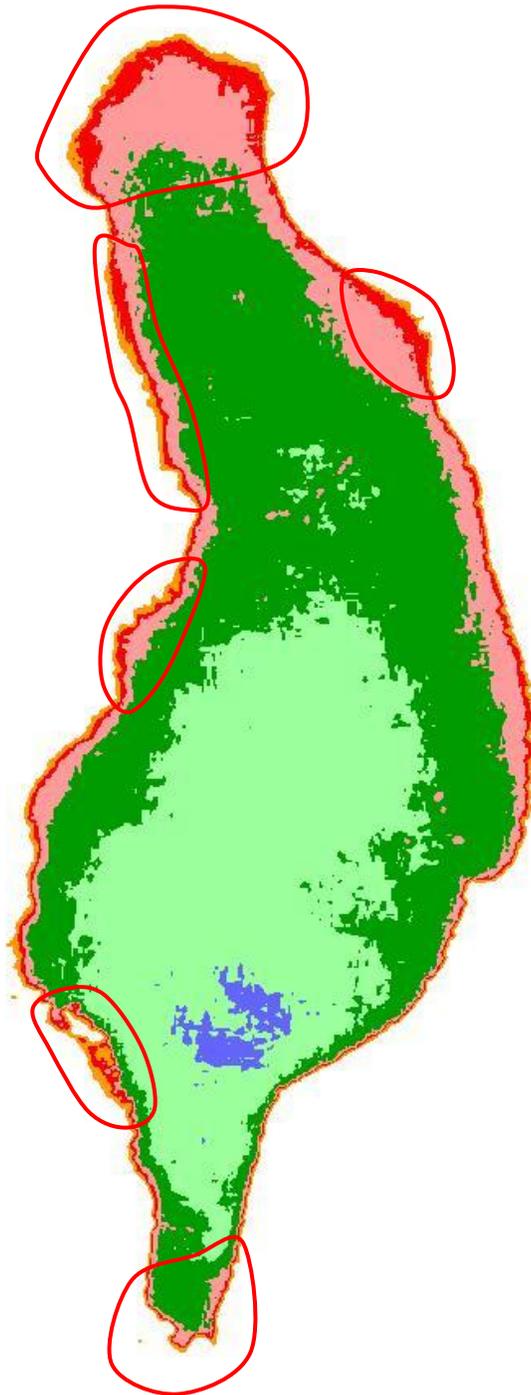
## Trophic Status Index Map

Red circles indicate priority areas of concern.

The TSI map shows a large variation in TSI values with the highest values along the shorelines. This is due to the fact that the majority of nutrient loading occurs near the shoreline where runoff from roads, lawns and septic leaks from shoreline properties enters the lake. There are a few areas where this loading appears to be heavier that have been circled in red on the TSI Map above.

The majority of the lake shows TSI values between 51 and 70, in the eutrophic range of the TSI scale. The northern end of the lake appears to have the highest levels of nutrient loading with the TSI values higher than the southern half of the lake; the inlet at this end of the lake makes it more susceptible to nutrient loading.

The areas of concern circled in the southern half of the lake contain high concentrations of emergent vegetation and algae that cause the TSI map to show very high TSI or to show up as land (white) in these areas. These high concentrations of plant material are due to higher nutrient input in these parts of the lake, the causes of which should be investigated.

To better understand the impact of nutrient loading on Upper South Long Lake, AWRL recommends the following:

1. The lake association should conduct basic groundtruthing in the areas circled in red on the TSI Maps to determine what potential sources could be contributing to the higher TSI values in these areas.

2. Conduct an Environmental Assessment Overflight in October 2011 of the Nokasippi River inlet into Upper South Long Lake. This flight will identify potential contributors to the high nutrient loading along the Nokasippi River flowing into the northern portion of Upper South Long Lake. Following the flight, identified locations should be groundtruthed by the association with AWRL's assistance.

3. Conduct a Groundwater Intrusion Overflight of the entire lake in the winter of 2011-2012 to pinpoint problem septic systems and springs that are influencing the lake. The information from the flight should then be used to mitigate septic or runoff problems and stop the nutrient loading at the source.
